TURBID DISCHARGE INCIDENT AT CANNONSVILLE DAM

John H. Vickers, P.E.¹ William H. Hover, P.E.²

ABSTRACT

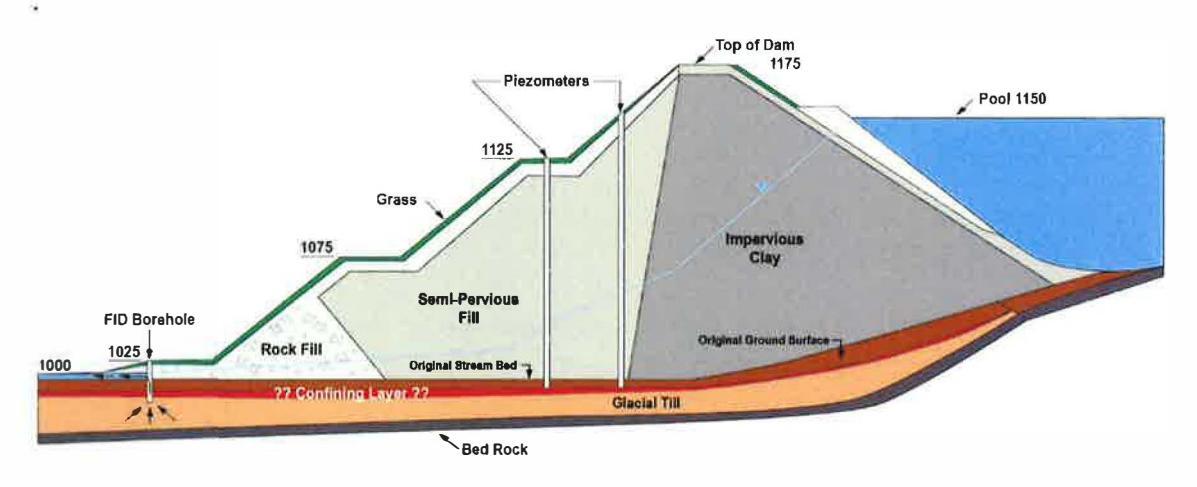
Figure 3 shows stone rip-rap armoring the upstream slope with stone fill below topsoil/turf on the downstream slopes. Benches with catch basins pass surface drainage through the near-surface rock fill. The rock fill toe passes surface drainage and dam seepage to the tailwater..

Figure 3. Inferred Dam Section During The Incident

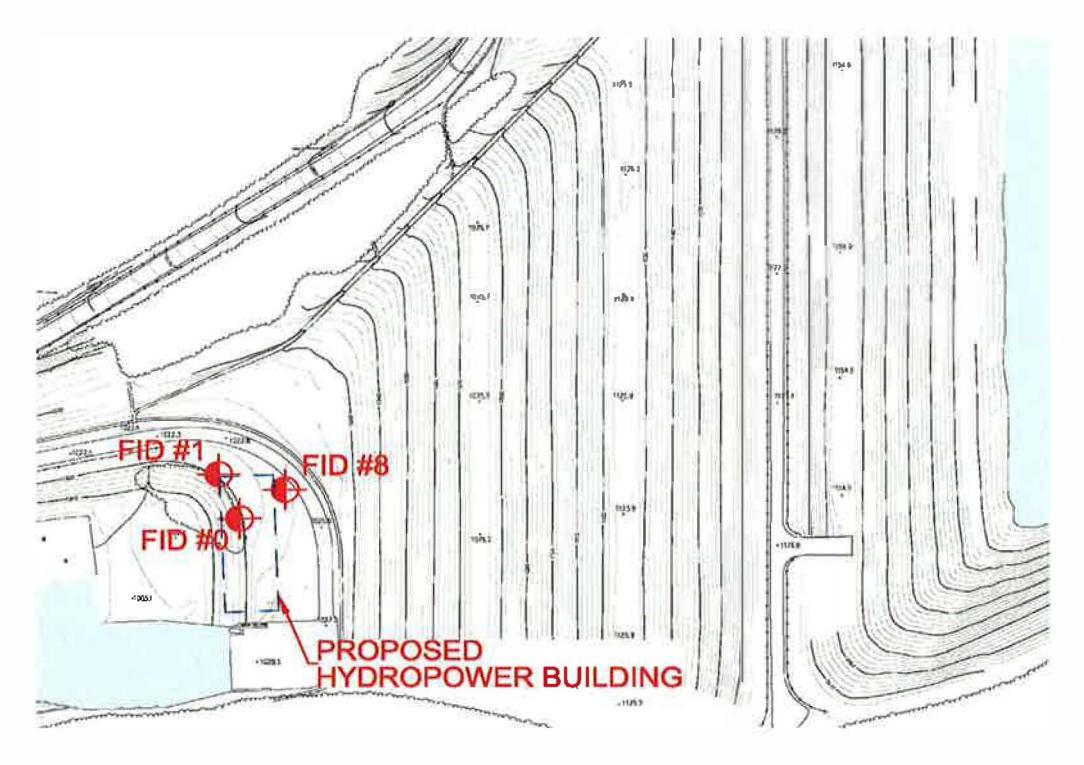
DEP filed for and FERC granted to NYC a license on May 13, 2014 to construct a 14.1 MW hydroelectric plant, with powerhouse located next to the release chamber (Figure 4). A hydropower consultant developed a plan to collect subsurface information and install piezometers to estimate seepage flows and measure pore water pressures in the powerhouse foundation (Figure 5). Eight borings were proposed and three were partially completed.

Figure 5. Locations Of Three Borings For Proposed Hydroelectric Plant

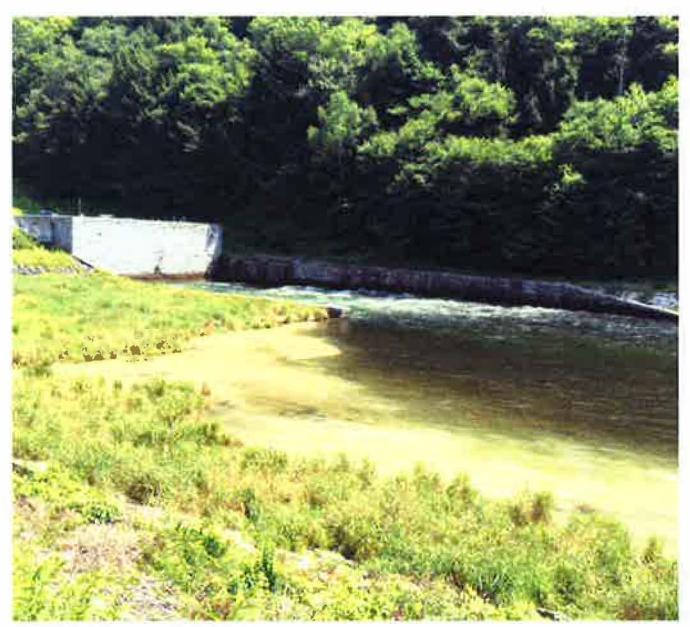
On July 8, 2015, turbid discharge was emanating from the toe into tailwater during the 3rd of 8 boreholes (FID-0) (Figures 5 and 6). FID-8 began on July 1, resuming on July 5 and was drilled through the rock toe via hollow stem augers (HSA) to 52 feet and uncased to about 62 feet by mud rotary methods. The driller had difficulty backfilling FID-8 on July 6 by pouring 9 bags (450 lbs) of bentonite chips, 1 cy of 1 in. stone, 3 cy of sand and 2 bags of bentonite chips into the borehole from ground surface after auger removal. FID-1 was drilled on July 6 and 7 with HSA to 29 feet and uncased to 61 feet by mud rotary methods. FID-1 was backfilled using bentonite mud and cuttings. After HSA removal the hole collapsed to 6 feet below grade and was backfilled with bentonite chips. FID-0 was drilled on July 7 and 8 in the same manner as FID-1. The borehole was filled with 60 gallons of cement grout bentonite grout prior to HSA removal, followed by borehole collapse to 6 feet and backfill with bentonite chips. The belief on July 8 was that drill cuttings, "recirculated mud" and backfill from previous holes were mixing with drainage and seepage causing turbid discharge. DEP stopped the borings to evaluate. After turbidity continued for 2 more days, with significant drops in deep piezometer levels beneath the dam, DEP notified FERC and NY State DEC Dam Safety and mobilized staff to the normally unoccupied site for 24-7 monitoring. DEP notified state, county and town officials and emergency managers. DEP contacted consultants who performed a comprehensive dam safety assessment in the past, to respond. In consult with FERC, DEP initiated reservoir drawdown on July 13 at a rate of 1,000 MGD (max. sustainable release); and increased max.supply diversion to 450 MGD.

Figure 6. Turbid Discharge At Downstream Toe - July 13, 2015

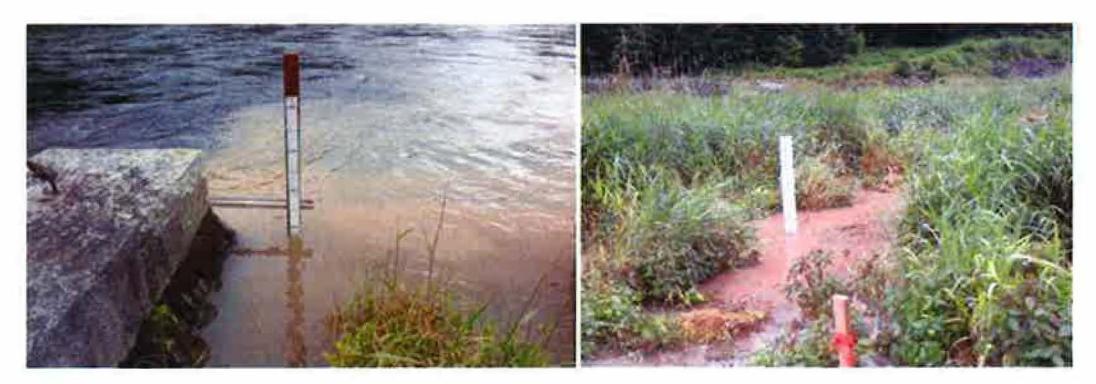
other means to provide 24-7 on site monitoring. DEP surveyors established control points to ensure the dam profile had not changed and erected staff gages in tailwater and on the toe area of turbid discharge to monitor changes in discharge water surface and tailwater elevations with automated pressure transducer (Figure 7). DEP began daily inspections

Figure 7. Staff Gages (Tailwater and Turbid Discharge)

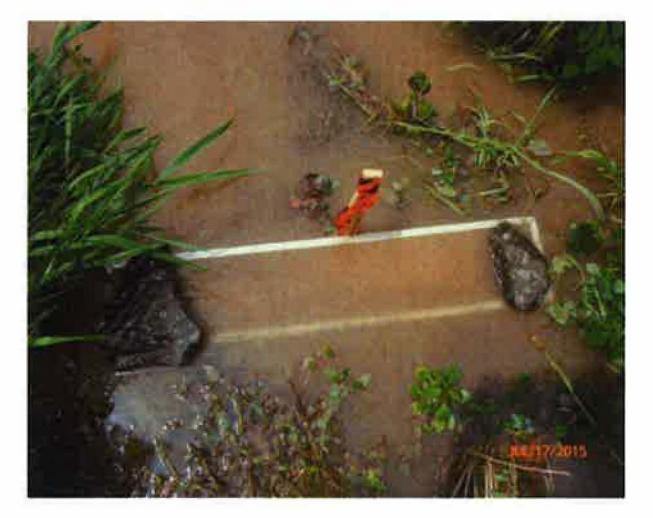
and photo documentation. The Automated Data Acquisition System reading interval of the piezometer array installed in 2000 was changed from daily to hourly, with twice daily analyses. DEP established deviation alarms and SOPs to notify engineers of rapid change of any piezometer. DEP built sediment collection boxes to examine grain size distribution of

Figure 8. Sediment Collection Box (36 in. x 12 in.)

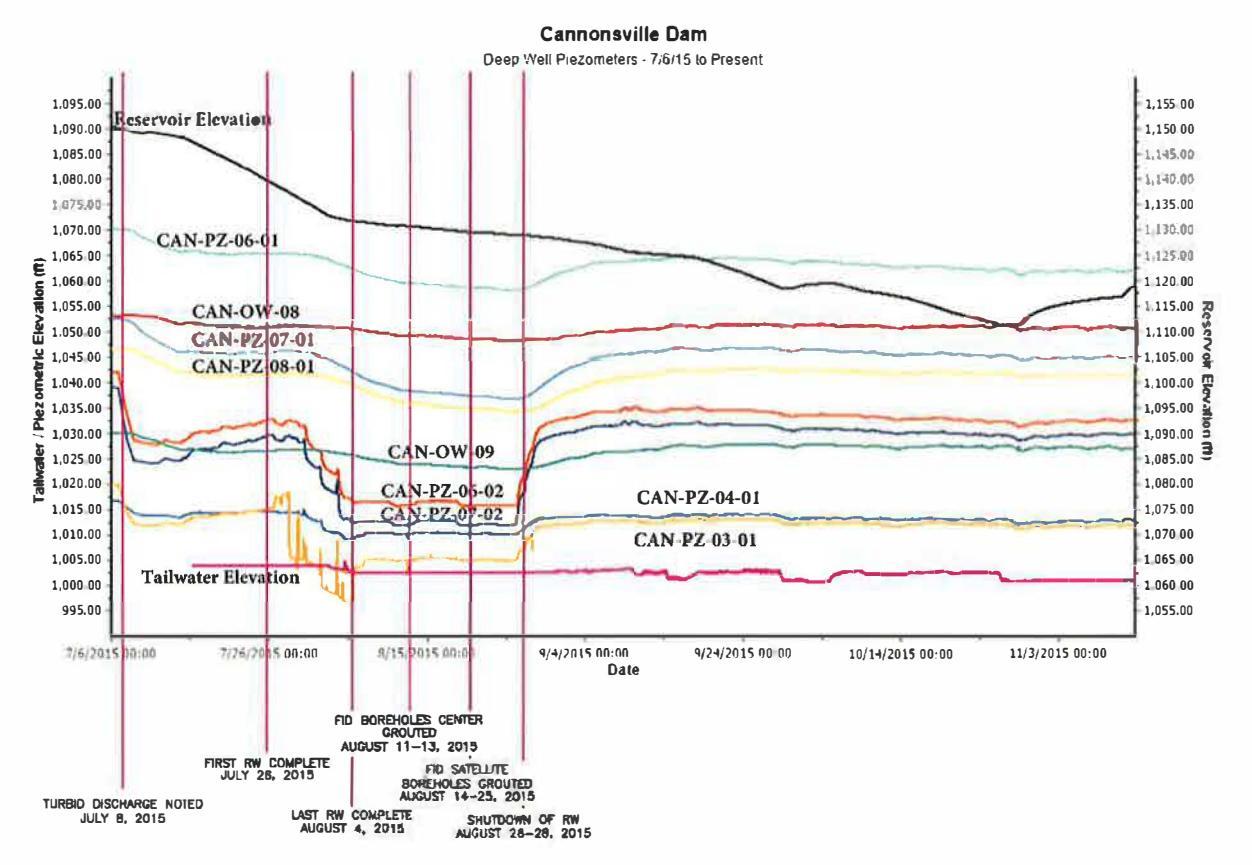
DEP engineers reviewed the piezometer data and discovered that deep piezometers in the dam foundation had 13 to 14 foot drops in head coincident with drilling of boreholes FID#1 on July 7 and FID#0 the next day and then remained relatively steady thereafter (Figure 9). An artesian well located about 200 yards downstream that has historically discharged freely through a 1 inch orifice and approximately 30 inches upward, had dropped to just a few inches above the orifice (Figure 10). The artesian well and the new boreholes were hydraulically connected in some manner.

Figure 9. Decreased Piezometer Levels Concurrent With FID Borings

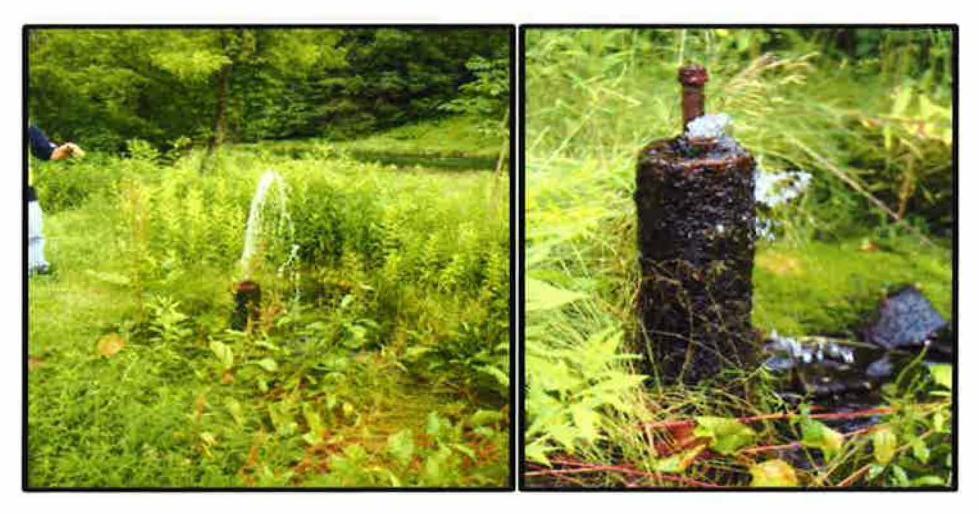
Figure 10. Artesian Well Before (left) and After (Right) New Borings

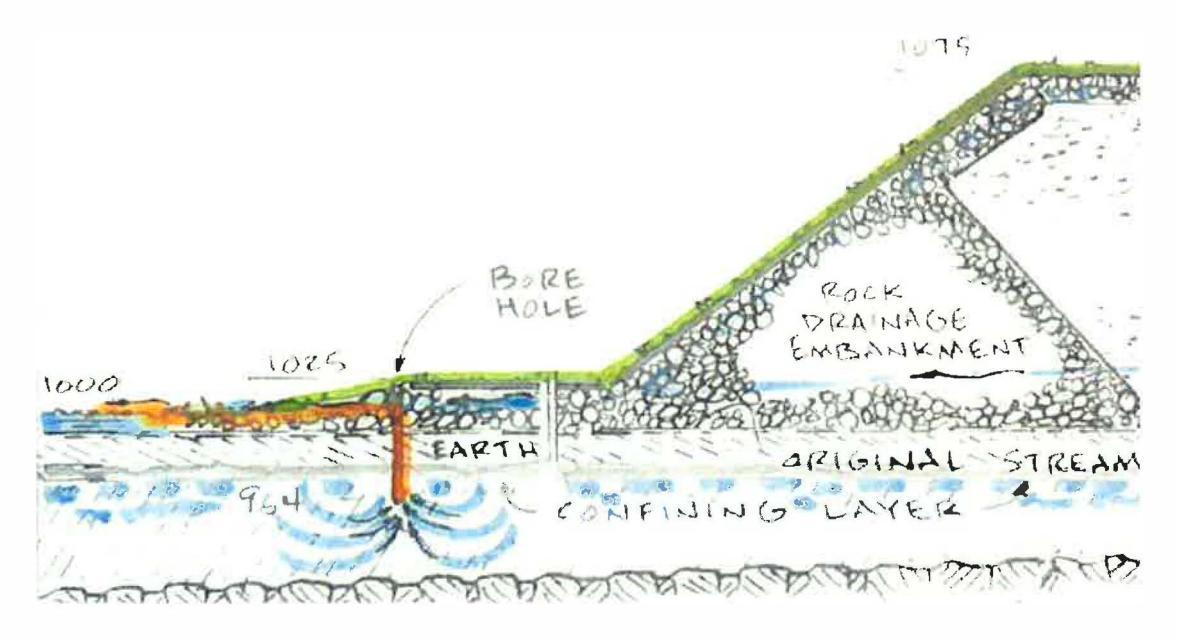
Figure 11 - Sketch by Jeffrey Helmuth, P.E. Illustrating Mechanism Of Artesian Flow

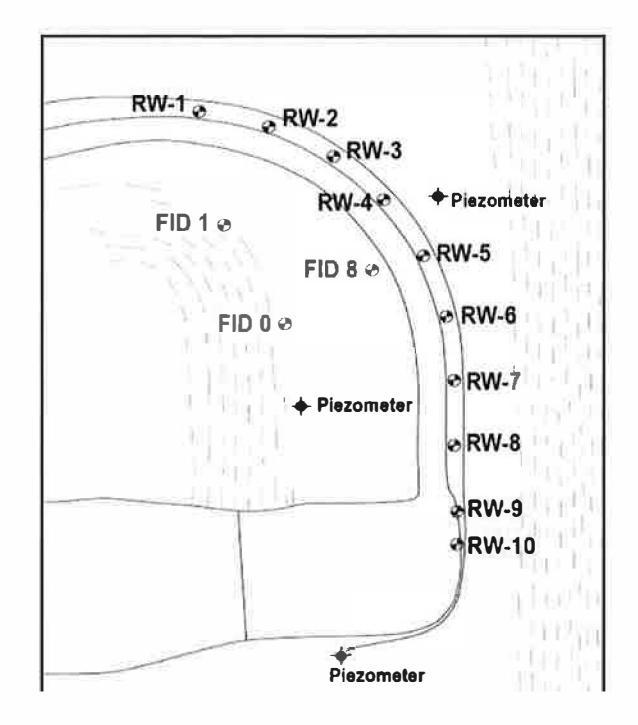
Figure 12 - Relief Well Location Plan

Using the experience of the GZA consultant, DEP archives, contractor's recommendations, and a collaborative effort with state and federal regulators and Board of Consultants, the project team settled on 10 temporary relief wells positioned in an arc up-gradient from the boreholes (See Figure 12). The relief wells were designed in a drainage curtain configuration upstream of the proposed powerhouse and along the right abutment at 40 ft. spacing for the 1st stage and 20 ft. spacing for a 2nd stage. Pumps would increase pressure relief, and the wells could be maintained for future use if appropriate. Relief well holes were drilled through permanent steel casings to control artesian pressure. The contractor recommended sonic drilling methods to rapidly advance the larger diameter casing through the rock toe with little or no water or air flushing which could exacerbate the condition. The wells were constructed with slotted PVC screen and solid PVC riser. The slotted section was backfilled with filter sand on top of which a bentonite plug was installed. The annular space above the screened zone was backfilled with cement grout. Well screens were set below the silt-clay confining

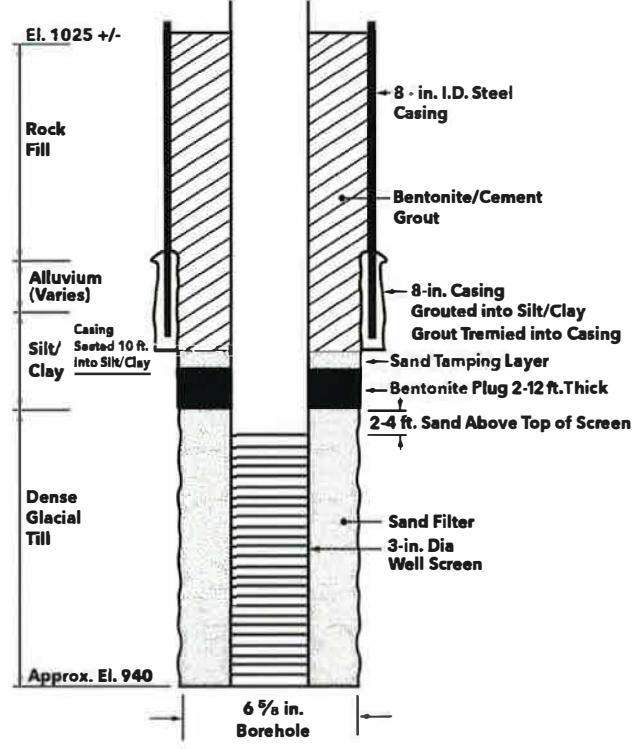
Figure 13. Relief Well Detail

layer to relieve the artesian stratum (Figure 13). Each relief well accommodated an electric submersible pump with a PVC discharge pipe fitted with a sampling port and flow meter and then connected to a collection header discharging into a sedimentation tank and then into an existing catch basin. Ready availability of sonic drill rigs and permanent casing for borehole installation limited screened diameters. Two different sizes of relief wells, with 3-inch and 4-inch diameter finished well screens, were installed. Ten (10) inch sonic drill casing allowed a permanent 8-inch steel casing to be grouted into the confining soil strata below the rockfill before advancing the hole into soils under artesian head. A careful evaluation was essential to provide a casing with adequate seal into the confining layer, before encountering the artesian stratum. During initial drilling, the extent and depth of the artesian zone was unknown.

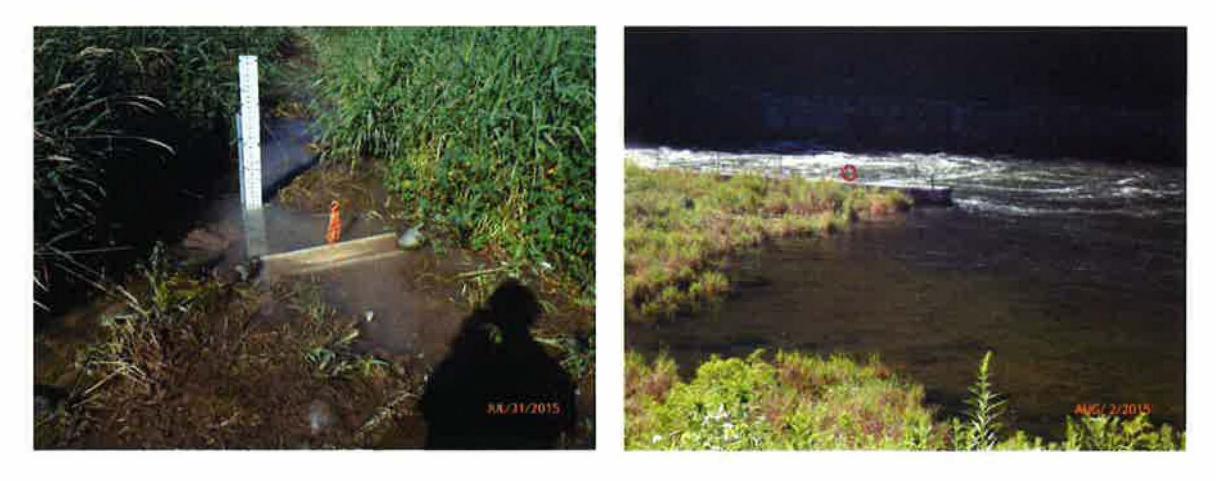
longer observed (Figures 14, 15). The relief wells were declared a success the next morning. Pumping only from the deep artesian stratum using RW-1, 2 and 3 revealed that it was the source of water causing turbid discharge. Further confirmation of the source of the erosive flow was provided when pumping was briefly stopped for electrical re-wiring and turbid seepage re-emerged. The construction photo (Figure 16) indicates the relic river channel corresponding to the stratified sands, silts, gravels and clays above of the silt-clay confining layer and underlying pervious artesian zone, and the location of the higher yielding wells and the piezometers that were highly responsive to pumping.

Figure 14. Staff Gage and Sediment Box Flow Rate, Turbidity Diminished July 31, 2015 – RW-1 at 50 gpm

Figure 15. Tailwater – No Turbid Discharge August 2, 2015

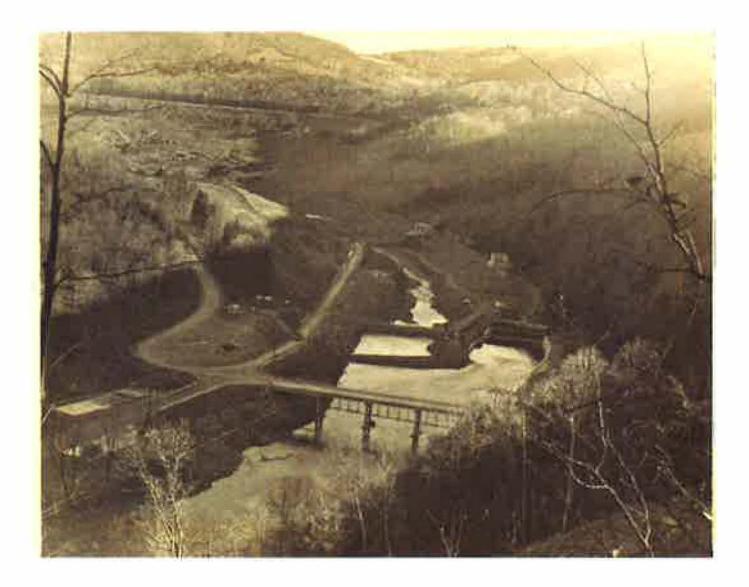
Figure 16. Dam Construction - Note Former Shallow River Channel

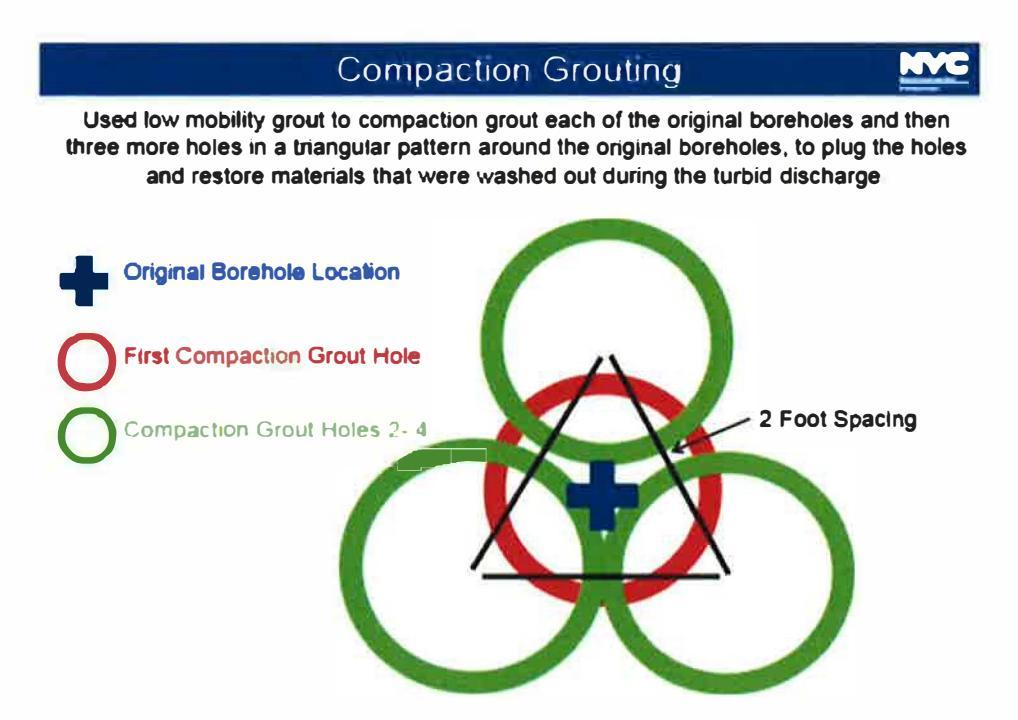
Figure 17. LMG Borehole Closure Pattern

The Phase 1 LMG grouting plan included an attempt to re-trace each exploratory hole and also three holes surrounding each FID borehole location on a triangular pattern (Figure 17). The re-traced holes were to clean out and backfill the FID boreholes and the surrounding three holes were to squeeze the FID boreholes closed if they could not be found and re-traced. The grouting plan included stand by time for dissipation of locally elevated porepressures. The LMG casing was advanced by internal flush duplex drilling to the target depth. The casing was then retracted in 2-ft (0.6-m) lifts as the grout was injected. For each lift, injection continued until pressure refusal, a pre-determined target grout volume was reached, or surface heave was observed. The team agreed that borehole re-tracing, cleaning out and grouting would be the most reliable closure expected. Special measures were taken to

give this approach the greatest success. Relatively flexible, specially selected 2.5 inch drill casing with a lost point tri-cone 3.5-inch diameter bit was advanced first with positive water flush so as to follow the existing FID borehole as closely as possible. The approach worked very well at each FID borehole location. Minimal resistance to the advancement of the drill string and an abrupt increase in density at termination depth of each FID holes was a conclusive indicator that the boreholes were re-traced to full depth.

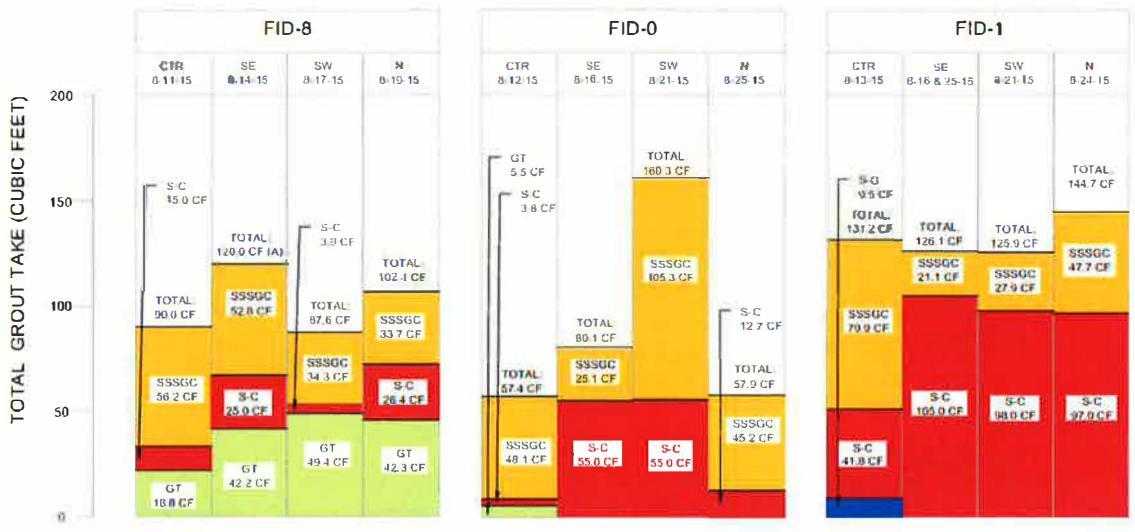
Following grouting of the 3 FID boreholes, grouting was performed on a triangular pattern around each FID borehole, based on the volumes of grout injected and concern about radial voids or loosened zones beneath the confining layer. Figure 18 shows the grout volumes injected vs depth at each FID borehole. The highest grout volume was observed at FID-1, which was suspected by the project team to be the most problematic based on its hydraulic connection to the artesian layer (Figure 18).
