TURBID DISCHARGE INCIDENT AT CANNONSVILLE DAM

John H. Vickers, P.E.¹ William H. Hover, P.E.²

ABSTRACT

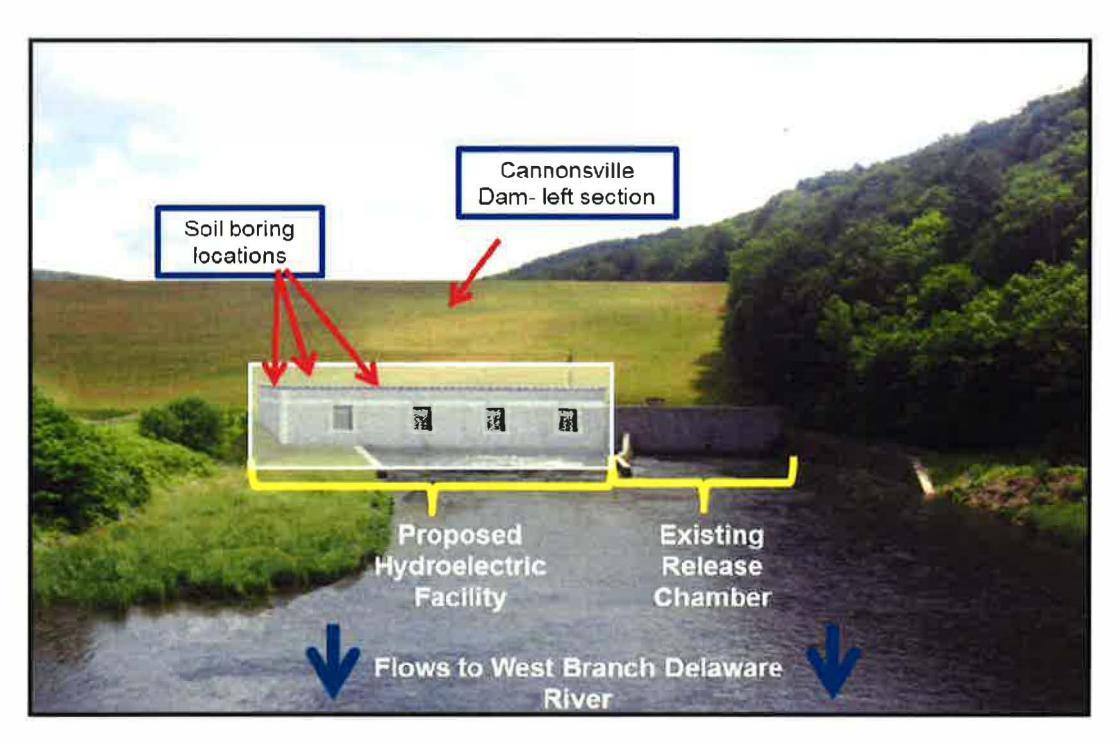
Figure 4. Conceptual Rendering Of Proposed Powerhouse

DEP filed for and FERC granted to NYC a license on May 13, 2014 to construct a 14.1 MW hydroelectric plant, with powerhouse located next to the release chamber (Figure 4). A hydropower consultant developed a plan to collect subsurface information and install piezometers to estimate seepage flows and measure pore water pressures in the powerhouse foundation (Figure 5). Eight borings were proposed and three were partially completed.
